Monitoring of a high speed railway viaduct

D.R.M. Milne, L.M. Le Pen, G.V.R. Watson,
W. Powrie, D.J. Thompson

Monitoring can provide evidence of behaviours leading to track defects. Monitoring was carried out on a defect near a structure expansion joint, on a high speed railway viaduct.

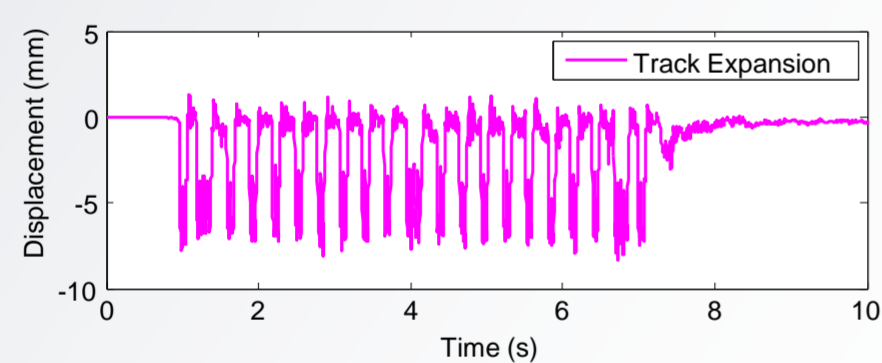
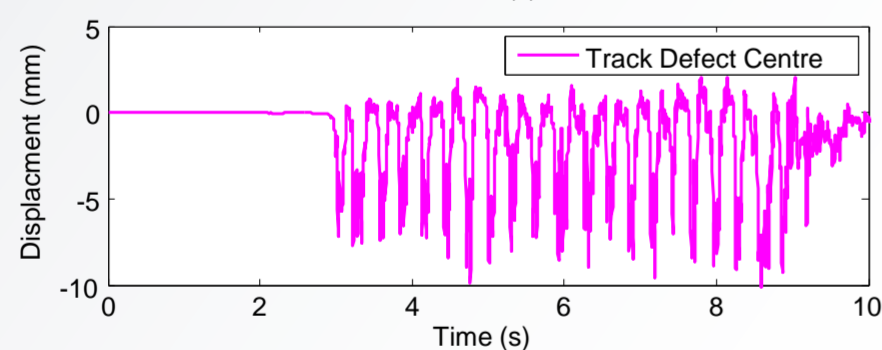
Figure 4 – Track displacement in defect from DIC

Geophone and DIC are useful for capturing the response of track and associated structures under operational conditions. DIC was effective for large displacements.

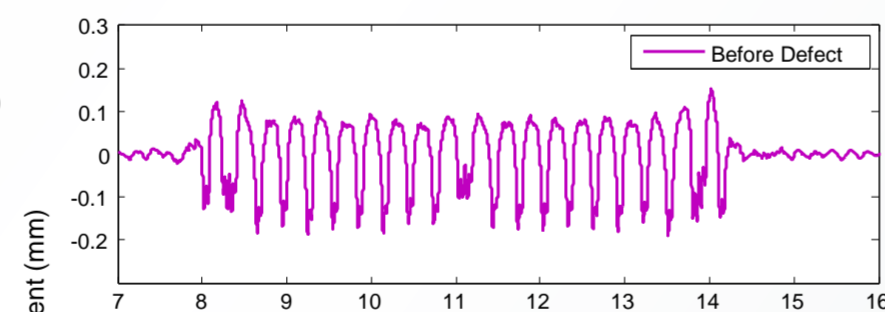
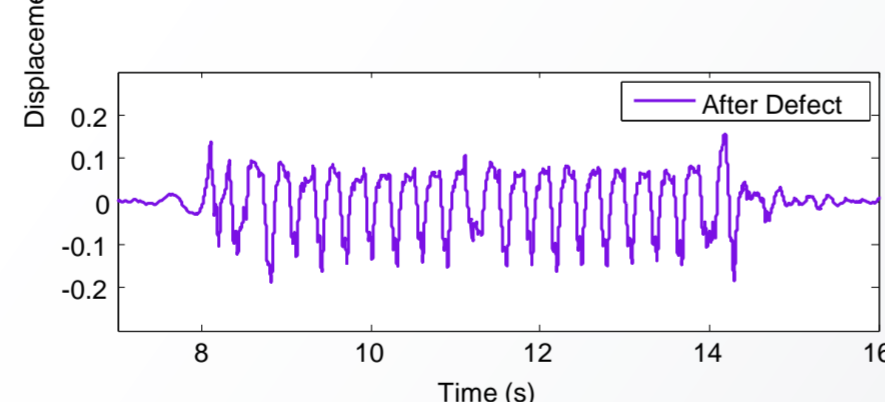
Figure 5 – Track displacement outside defect from geophones

Geophone results show that away from the defect track was performing well, displacing up to 0.5 mm.

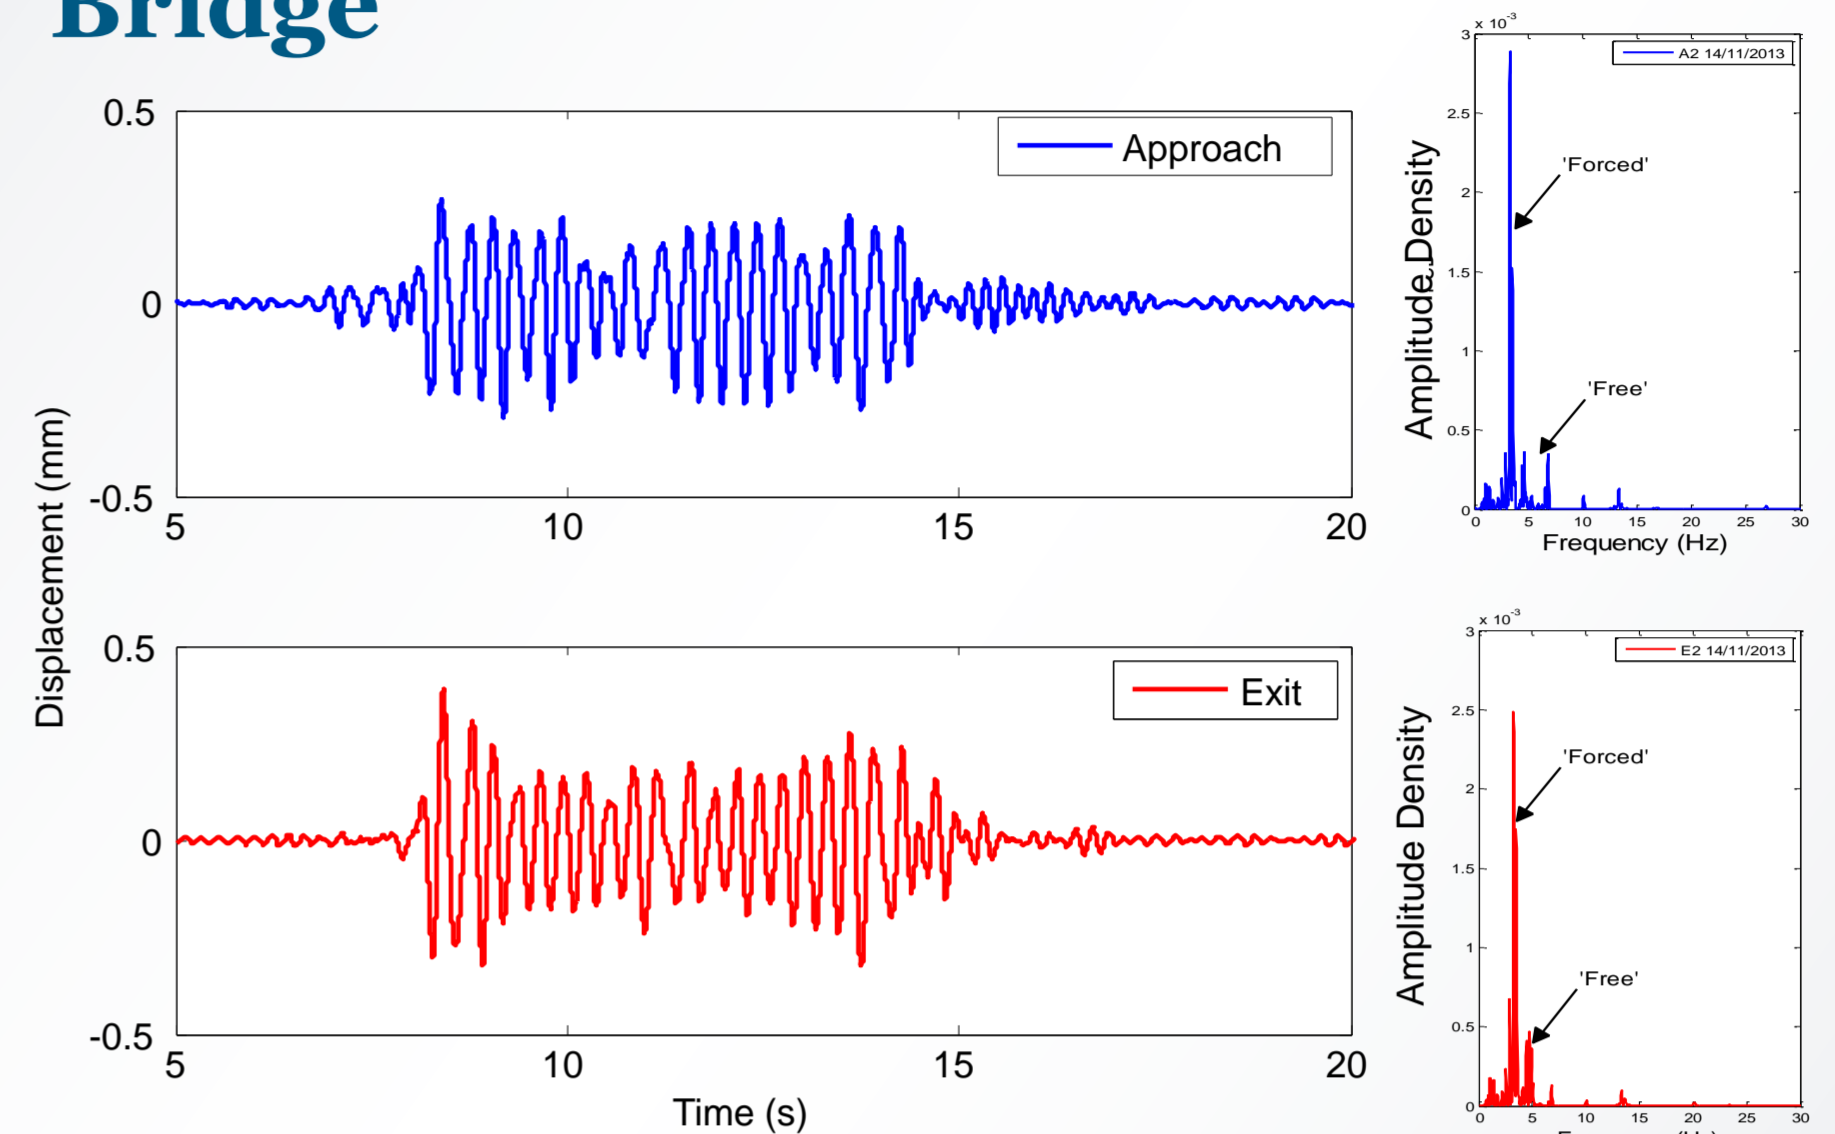
Figure 6 – Bridge span displacements and frequencies 6 m either side of expansion joint measured by geophone

Measurement, 6 m from the joint, suggested the bridge spans were being forced close to their natural frequency, meaning dynamic effects could be significant.

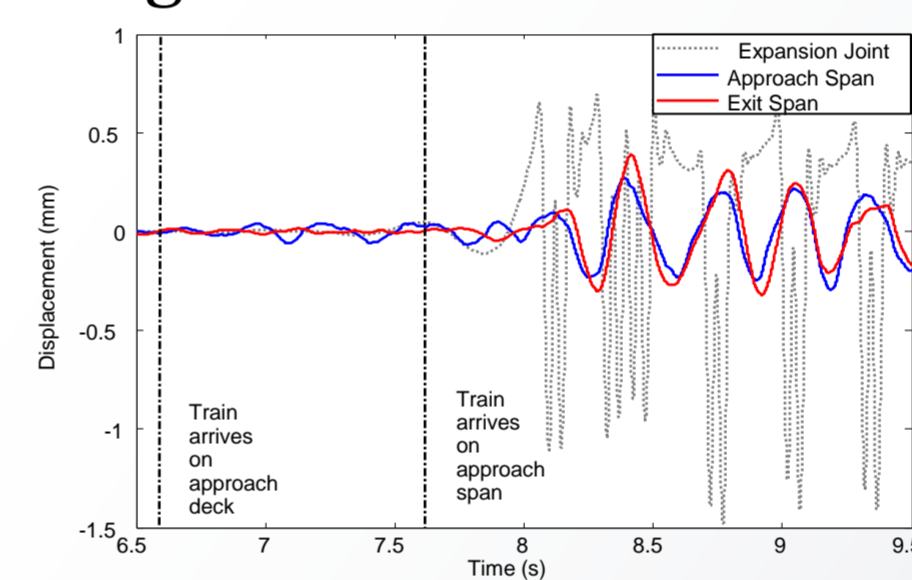
Figure 7 – Relative displacement of span to track over expansion joint

Maximum displacement of the spans either side of the defect occurred simultaneously and when the defect was not loaded.

Whether this response results in unfavourable geometry, increased dynamic loading or settlement warrants further investigation.
