Monitoring of a high speed railway viaduct

D.R.M. Milne, L.M. Le Pen, G.V.R. Watson,
W. Powrie, D.J. Thompson

Monitoring can provide evidence of behaviours leading to track defects. Monitoring was carried out on a defect near a structure expansion joint, on a high speed railway viaduct.

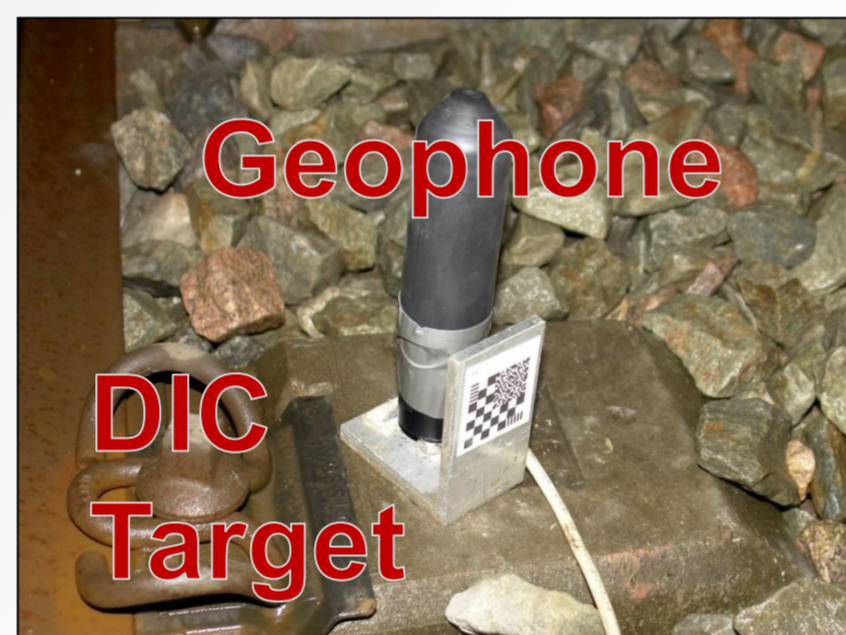
Figure 3 – Geophone and DIC target

Geophones and high speed video for digital image correlation (DIC) captured the response of the track and bridge spans in and around the defect.
