## **Mechanical and hydrological impacts of tree removal on a clay fill railway embankment**

Smethurst J A, Briggs K M, Powrie W, Ridley A, Butcher D. J. E.

### **Abstract**

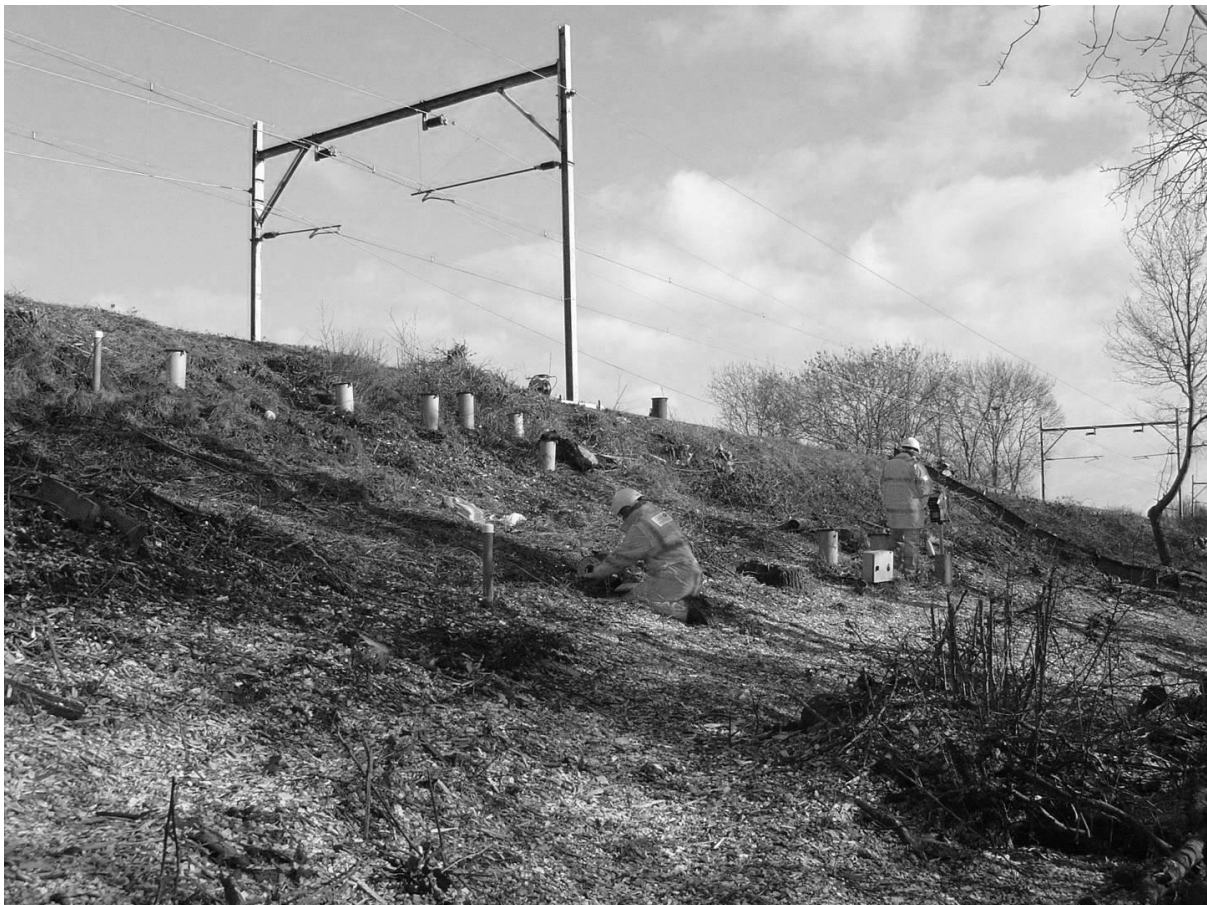
Figure 2: Photograph showing the south side of the embankment in March 2010, shortly after the second vegetation clearance.

The instrumented site is on the Shenfield-Southend Victoria railway line near Hawkwell, north of Southend, Essex, UK (OS grid reference TQ856923; Fig. 1). The embankment at the instrumented location is 5.5 m high, and is constructed from a fill consisting mainly of London Clay excavated from adjacent areas of cut (Figs. 2 and 3). The *in situ* geology

Trees were removed from the upper two-thirds of the slopes over the 20 m long instrumented section during March 2007, as shown in Fig. 3. The felled trees were mainly oak (*Quercus robur*), with some ash (*Fraxinus excelsior*). The National House Building Council (NHBC) guidance on building near trees (NHBC, 2007) classifies oak as being of high water demand, and ash of moderate water demand. Further tree clearance occurred in March 2010, along the full length of the embankment. All of the trees adjacent to the instrumented section were felled, leaving only two semi-mature trees close to the ditch at the toe of the south facing slope. Between March 2007 and the second tree clearance in March 2010, small saplings and other scrubby vegetation became re-established on the slopes.

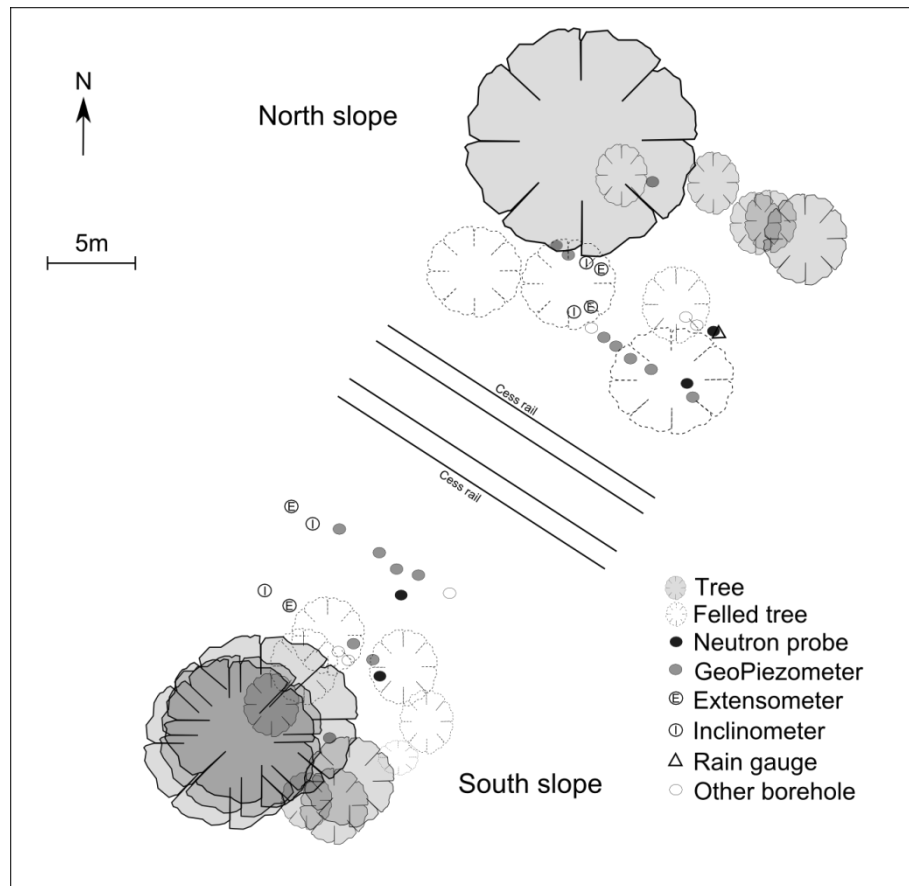
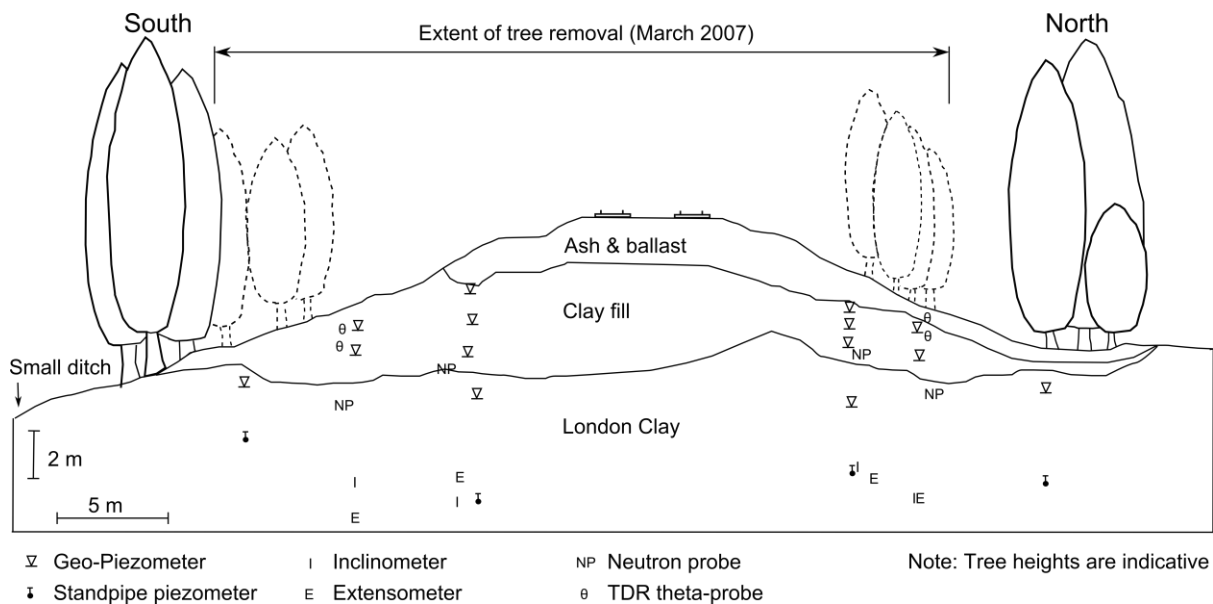
Figure 3: Location of instrumentation at Hawkwell embankment, shown (a) in plan; and (b) in cross section. In (b), the symbols mark the maximum depth of each installation, and tree form and height are not drawn to scale. Redrawn from Arup (2007).

Instrumentation was installed broadly in three groups on each side of the embankment, at the crest, midslope and towards the toe, as shown in Fig. 3. Instruments included deep standpipe piezometers, flushable piezometers, neutron probe access tubes, time-domain-reflectometry sensors for measuring water content, inclinometer tubes and magnet extensometers (Table 1). A datalogged tipping bucket rain gauge was installed on the north slope to measure rainfall at the site.

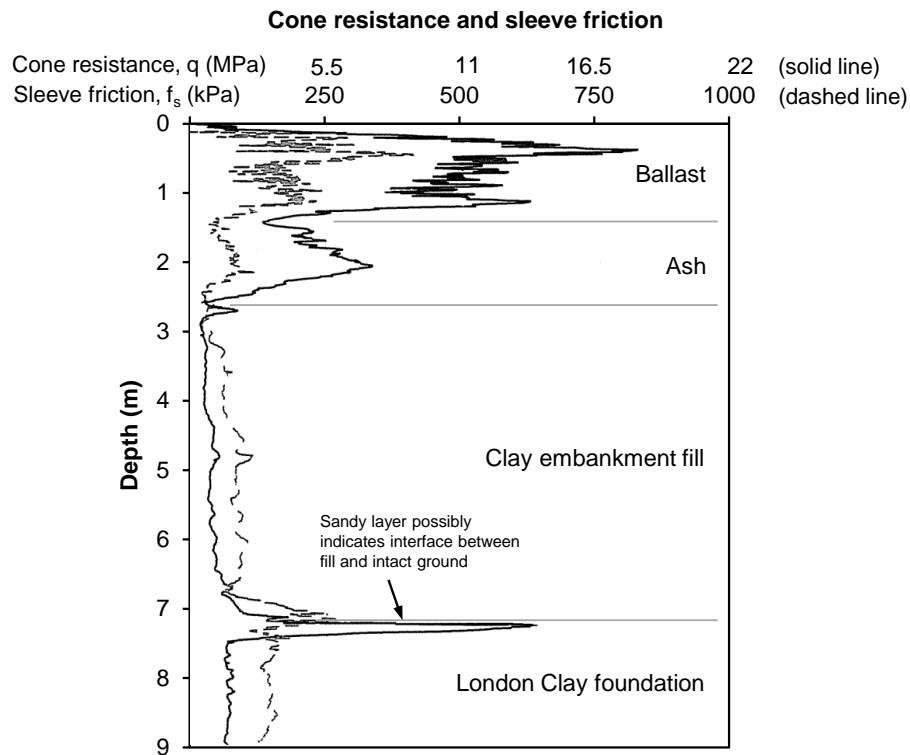
Figure 4: CPT data taken through the centre of the embankment midway between the up and down lines.

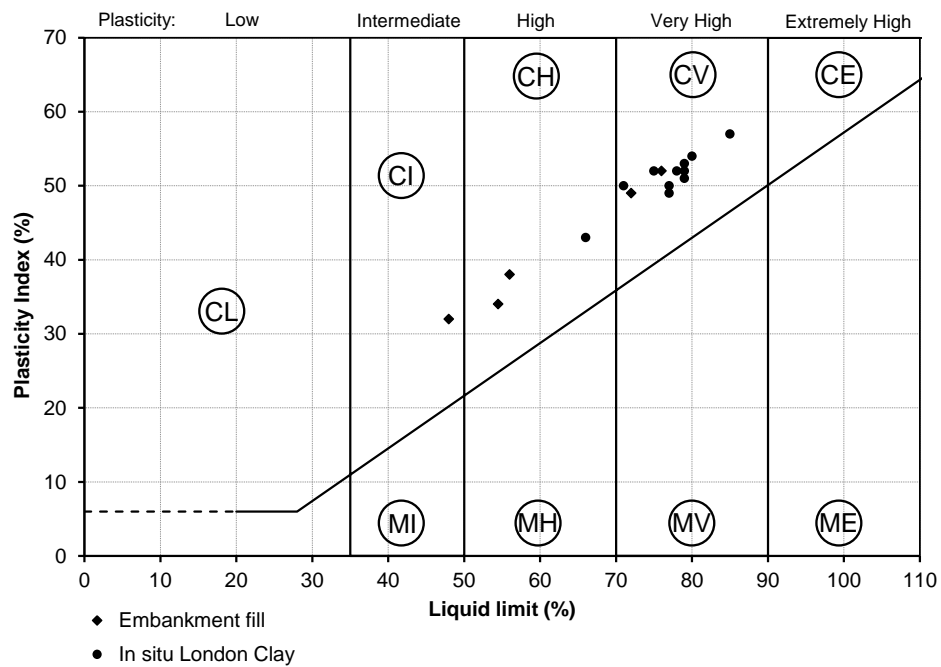
Figure 5: Plasticity of *in situ* London Clay and embankment fill

Both the embankment fill and the *in situ* London Clay beneath the embankment are weathered, as evidenced by their brown-yellow colouring. The clay fill contains occasional fine to coarse gravels, small pockets of ash and sand, and fragments of brick. Disturbed samples of the intact London Clay and clay fill were used to determine water contents and liquid and plastic limits (Fig. 5). Generally, the London Clay is of higher plasticity in the east of the London basin than the west (Burnett & Fookes, 1974); at the study site, the *in situ* London Clay was of very high plasticity. The embankment fill was classified as intermediate to very high plasticity.

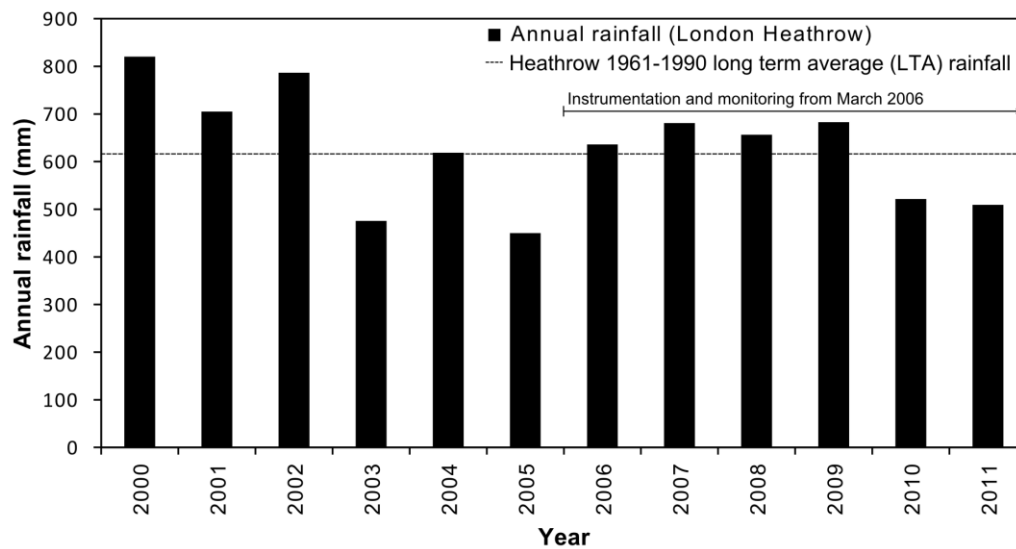
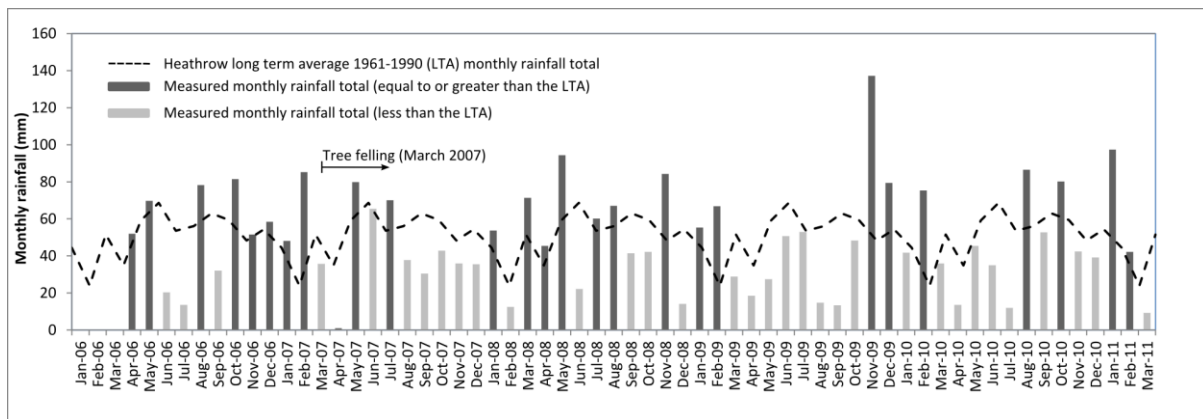
Figure 6: (a) Annual rainfall totals measured at London Heathrow (2000-2011); (b) Monthly rainfall totals measured at Hawkwell over the monitoring period.

Annual rainfall totals before and during the monitoring period are shown in Fig. 6(a) for London Heathrow, 80 km from the Hawkwell embankment site. These data show that the years preceding the monitoring period (2003 and 2005) were drier than the London Heathrow 1961-1990 long term average (LTA). An absence particularly of summer rainfall may cause significant soil drying and development of pore water suctions (Smethurst *et al.*, 2012).

Fig. 6(b) compares monthly rainfall totals measured at Hawkwell between April 2006 and March 2011 with the London Heathrow 1961-1990 long term average (LTA). The data show wetter than average summers in 2007 and 2008 (immediately after tree felling), with a drier than average autumn and winter in between.

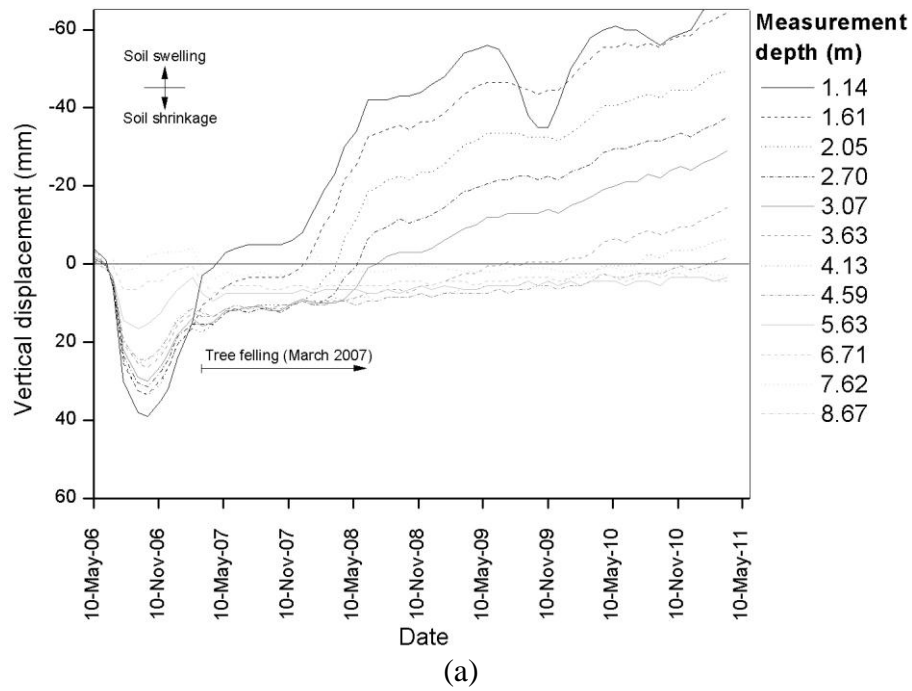
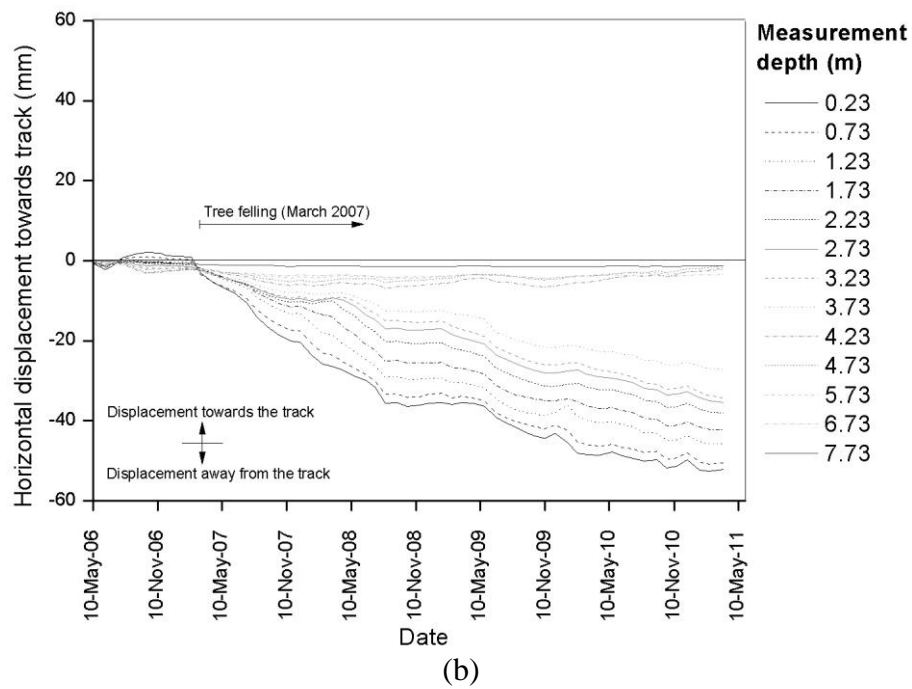
Figure 7: North crest installations: (a) vertical extensometer displacements plotted relative to initial magnet positions in April 2006; and (b) horizontal inclinometer displacements plotted relative to initial positions in April 2006.

Figs. 7 and 8 show extensometer and inclinometer data plotted against time for installations at the crest (north slope) and midslope (south slope) of the embankment.

At the north crest of the embankment (Fig. 7), 40 mm of vertical shrinkage occurred in the summer of 2006 when trees were present on the embankment slope. This was recovered by swelling over the ensuing autumn and winter period. Following removal of the trees in March 2007, continual swelling occurred through to the end of the monitoring period, with substantial upward and outward displacements measured. The largest vertical and lateral displacements occurred between 0 m and 3.5 m depth, with smaller displacements at greater depths. Swelling was particularly pronounced over the spring of 2008, which was very wet and followed a wet summer (Fig. 6b); some reversal of movement (shrinkage) was measured in the summer of 2009, which was drier than the long term average.

Swelling occurred at the north crest immediately after tree removal (Fig. 7), while swelling at the south midslope was delayed and of smaller magnitude. The south midslope measurements may have been influenced by the trees remaining at the toe of the slope, which continued to create a clear seasonal variation in the readings between 0 m and 2 m depth.

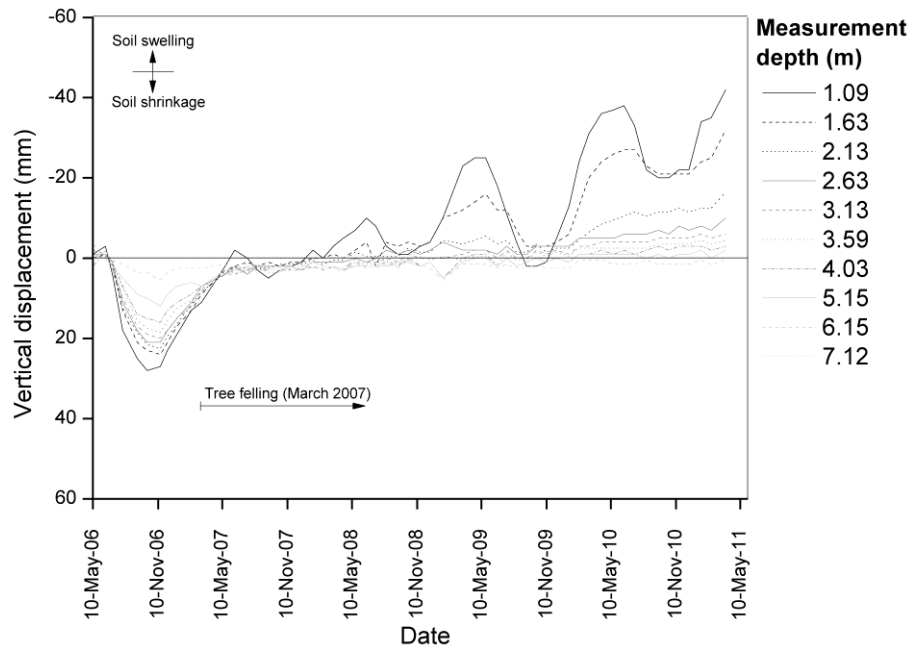
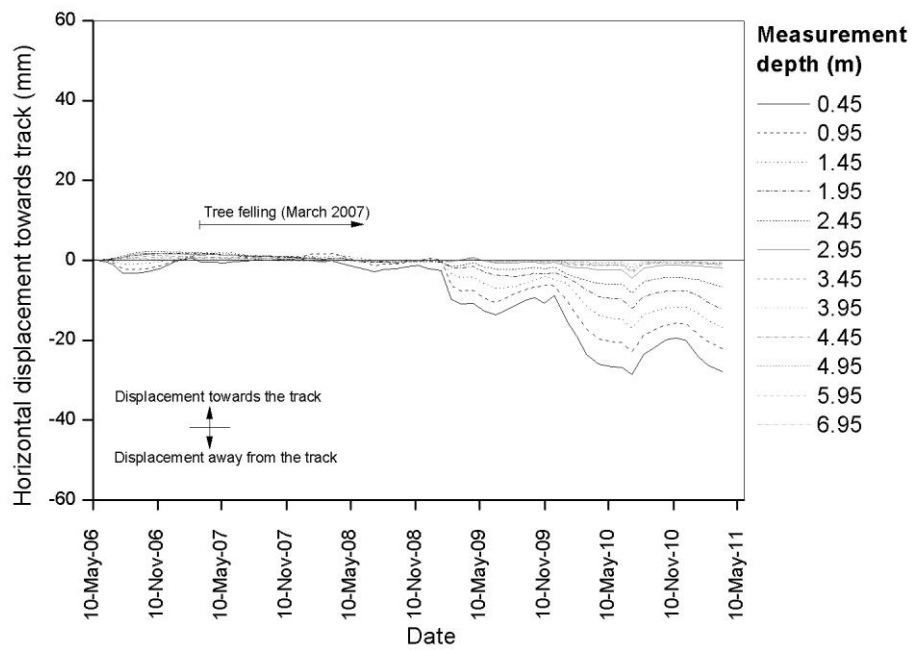
Figure 8: South midslope installations: (a) vertical extensometer displacements plotted relative to initial magnet positions in April 2006; and (b) horizontal inclinometer displacements plotted relative to initial positions in April 2006.

At the south midslope of the embankment (Fig. 8), shrinkage occurred throughout the soil profile in the summer of 2006 and was largely recovered in the following winter and spring. Vertical seasonal shrink/swell movements continued between 0 m and 1.63 m depth in subsequent years with a general trend of upward heave, while at greater depths some small (<10 mm in total) ongoing upward vertical displacements were measured. Significant lateral outward displacements, occurring between 0 m and 1.95 m depth, began in March 2009 - almost 2 years after the trees had been removed from the slope.

Fig. 16 compares the vertical displacements at approximately 1 m depth at the midslope of the embankment measured using magnet extensometers (as shown in Fig. 8a) with those calculated from the changes in volumetric water content measured by the neutron probe, assuming isotropic shrinkage of a zone of soil between 1 m and 3 m depth. This ignores desaturation of the soil in both the structural and residual phases of soil drying (Biddle, 1998), and may therefore tend to overestimate the soil volume change. The wetting and drying phases calculated from the neutron probe data correspond to the measured shrinking and swelling phases of the soil. The soil swelling due to water infiltration is indeed overestimated, while shrinkage is underestimated. This could be because the depth of soil drying (and hence shrinkage) is beyond the extent of the neutron probe measurements (i.e. below 3 m depth, Fig. 10b), and/or because shrinkage manifests disproportionately as vertical settlement rather than lateral contraction and tensile cracking (Driscoll, 1983).

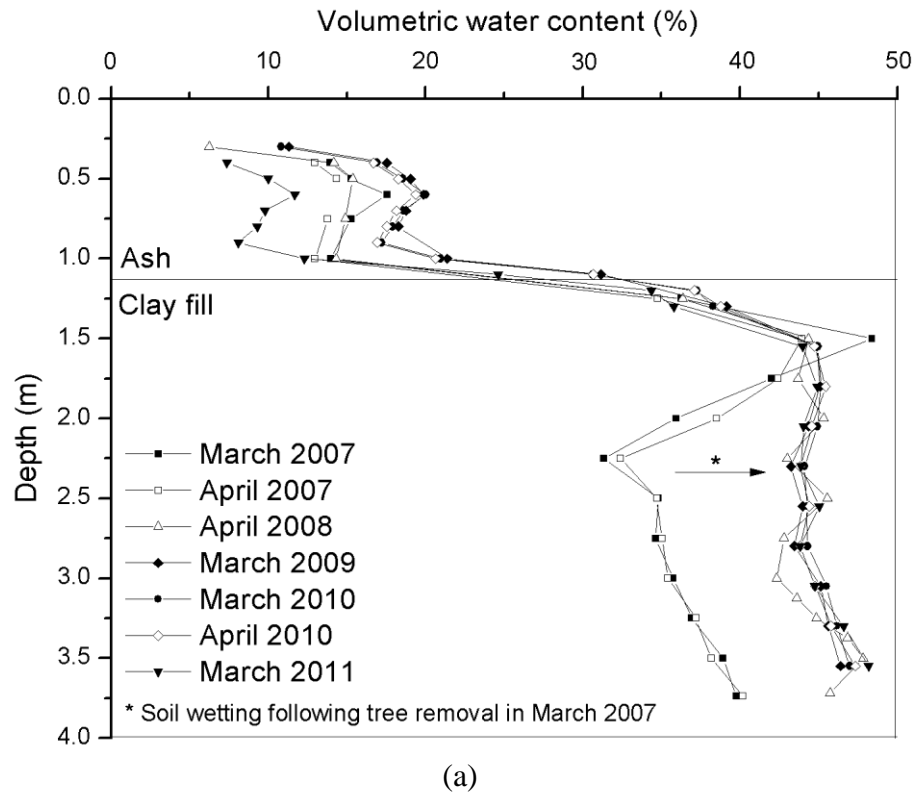
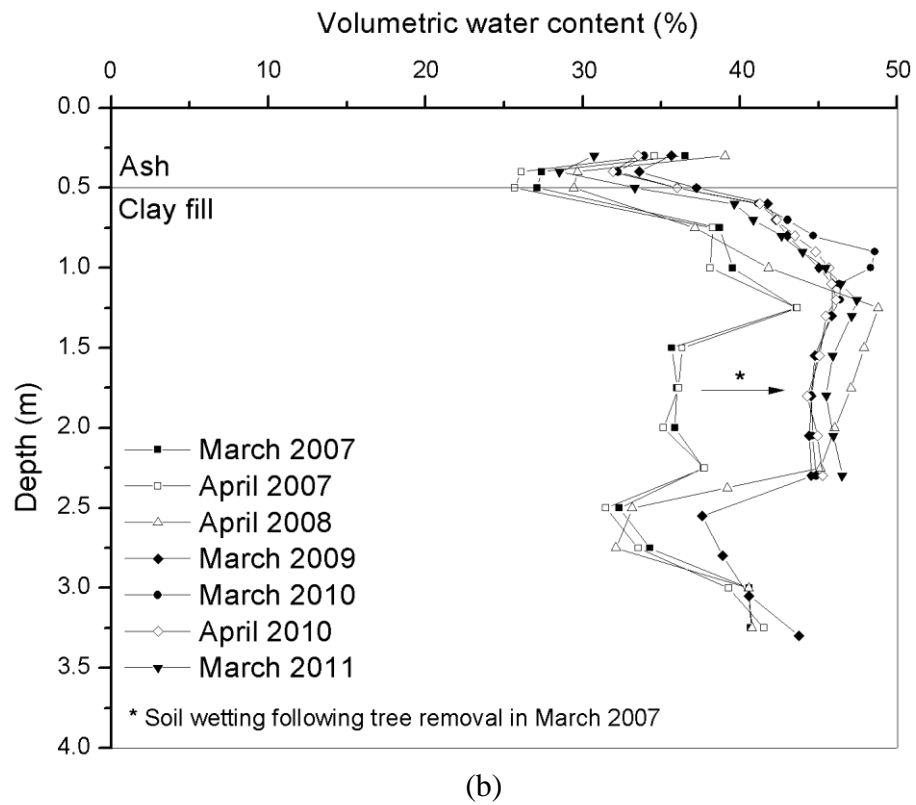
Figure 9: End of winter (March – April) volumetric water contents, north embankment slope: (a) crest; (b) midslope.

Figs. 9 and 10 show profiles of volumetric water content ( $\theta$  = volume water/total volume) with depth measured at the end of winter (March / April) throughout the monitoring period. The driest profiles were measured during March and April 2007, when trees were present on the embankment slope. Following tree removal, higher volumetric water contents were measured, approaching saturation at  $\theta \sim 45\%$  (which is consistent with other *in situ* measurements for London Clay: Croney, 1977; Biddle, 1998; Smethurst *et al.*, 2006). On the north side of the embankment (Fig. 9), the volumetric water content increased from a dry profile to a near-saturated profile between April 2007 and April 2008, consistent with the rapid swelling shown in Fig. 7(a). On the south side of the embankment (Fig. 10), considerable, but not complete, rewetting of the soil profile occurred in March 2009, one year later than on the north side. This is consistent with the relative patterns of vertical and lateral displacements (Fig. 8).

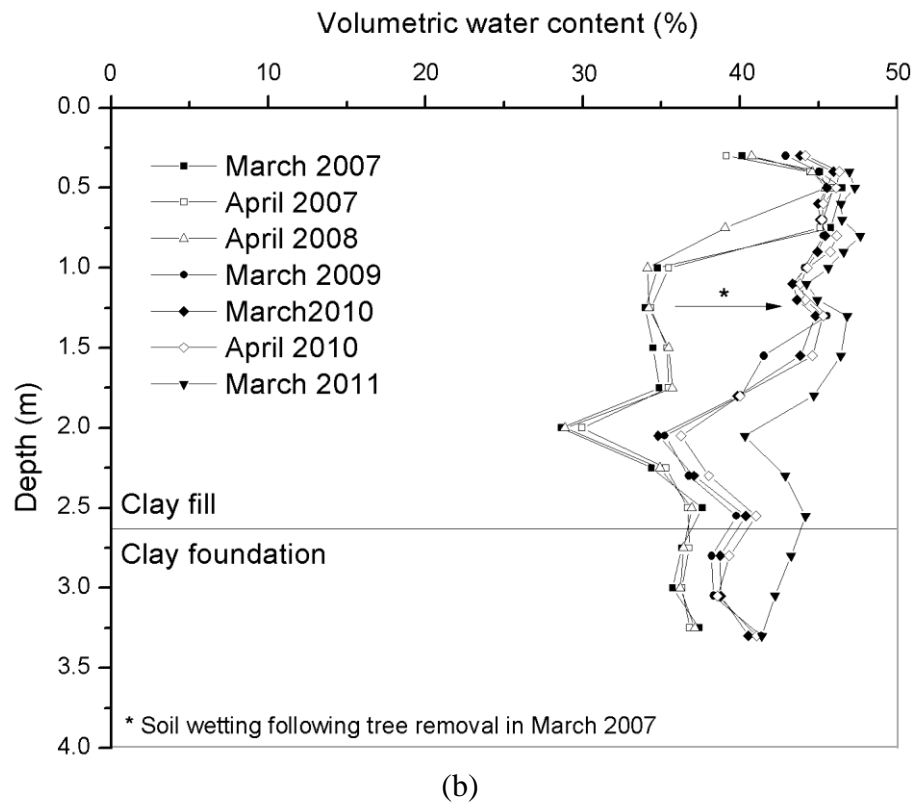
Figure 10: End of winter (March - April) volumetric water contents, south embankment slope: (a) crest; (b) midslope.

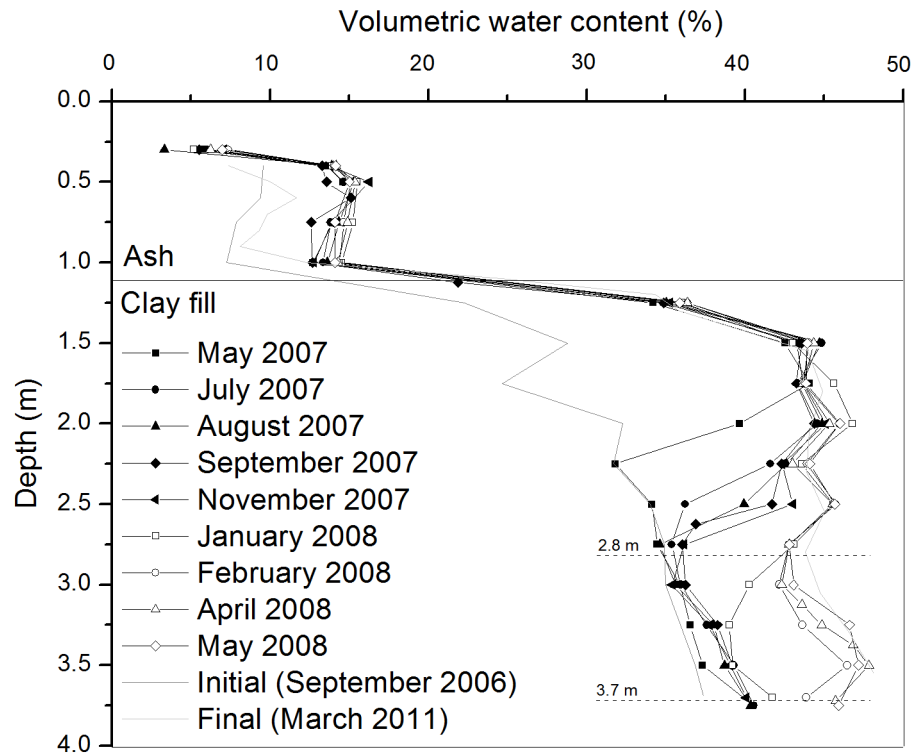
Figure 11: North crest volumetric water content variation from May 2007 to May 2008, with initial and final measurements shown for comparison

Fig. 11 shows a sequence of neutron probe readings for the north crest after tree removal, as the embankment fill reached saturation between 2.0 m and 3.75 m depth. The plot shows a sharp transition from the dry soil at approximately 35% water content to near saturation at 45% volumetric water content, which moves progressively downward over time. This is consistent with classic wetting front infiltration into an unsaturated soil (e.g. Gavin & Xue, 2008). In reality, the wetting front might be sharper with the transition from dry to wet soil occurring over a smaller depth than shown, because the neutron probe measures the average water content within a sphere of soil of radius  $\sim 140$  mm and is therefore unable to define the wetting front more precisely.

Comparison of the piezometer and neutron probe measurements for the north crest show that the true sharp increases in pore water pressure coincide with the soil water content reaching saturation at that depth (Fig. 11). At 2.8 m depth the soil profile reaches saturation between November 2007 and January 2008 (Fig. 11), while the pore water pressure increases sharply from -54 kPa to 0 kPa during the same period (Fig. 12). Similarly, at 3.7 m depth the soil profile reaches saturation between February 2008 and April 2008, when the pore water pressure increased from -30 kPa to 0 kPa. The rapid change in pore water pressure corresponds to the progression of a sharp wetting front into the soil, above which the soil is saturated. The water content profiles measured after May 2008 show that the soil then remained saturated at 2.8 m and 3.7 m depth, consistent with the continuous measurement of pore water pressures close to 0 kPa over the same period.

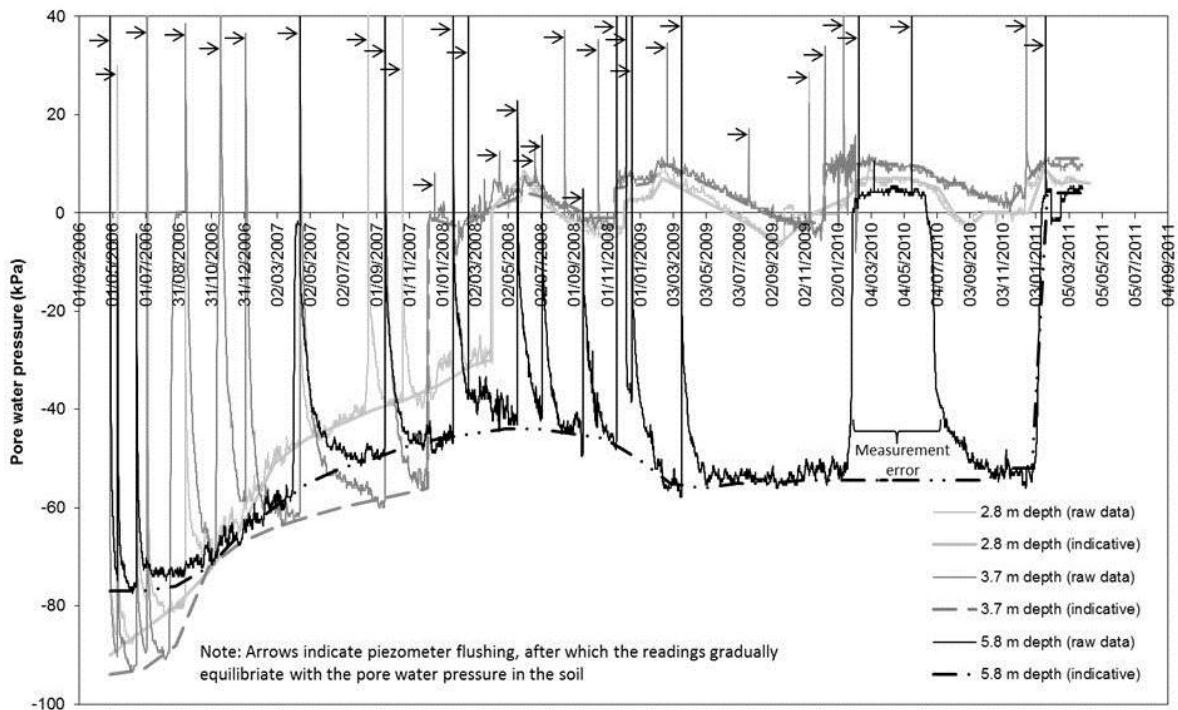
Figure 12: North crest piezometer measurements at 2.8 m, 3.7 m and 5.8 m depth, with indicative trend lines for pore water pressure shown. The spikes to positive pore pressures indicate piezometer flushing taking place, after which the readings slowly come back to equilibrium with pore water pressures in the soil.

Pore water pressures measured at the north crest of the embankment at depths of 2.8 m, 3.7 m and 5.8 m are shown in Fig. 12. The apparent sharp returns to positive pore pressure followed by a gradual recovery of the reading occur as the instrument is flushed to remove any build up of air. Indicative trend lines ignoring these spikes are plotted over the raw piezometer data; these show genuine sharp increases in pore water pressure at 2.8 m depth on 6 December 2007 and at 3.7 m depth on 1 April 2008. At 5.8 m depth, a more gradual increase in pore water pressure is evident up to the summer of 2008.

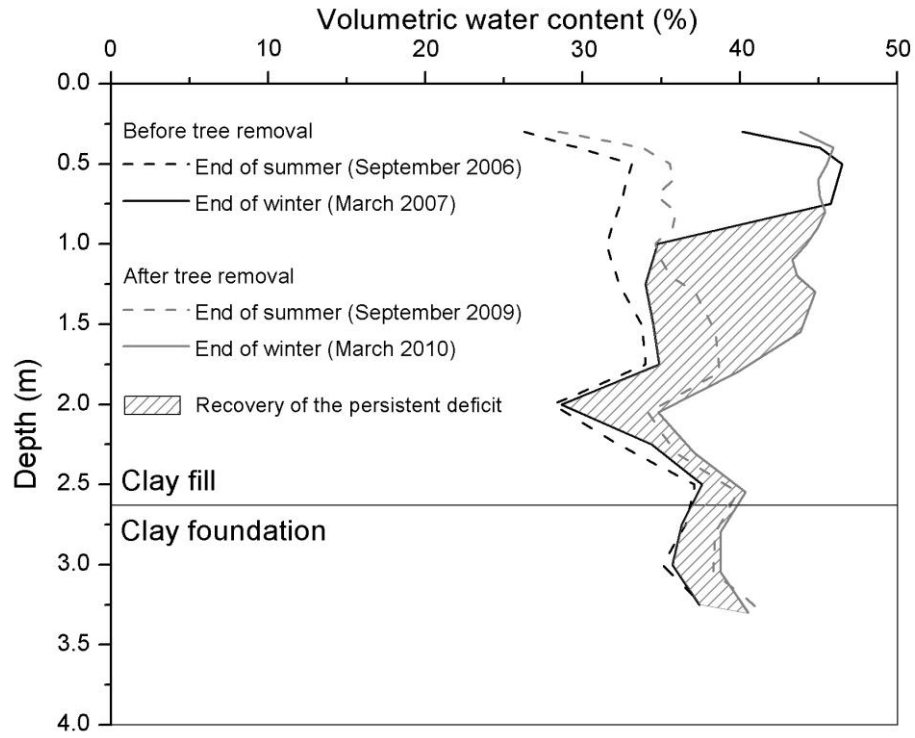
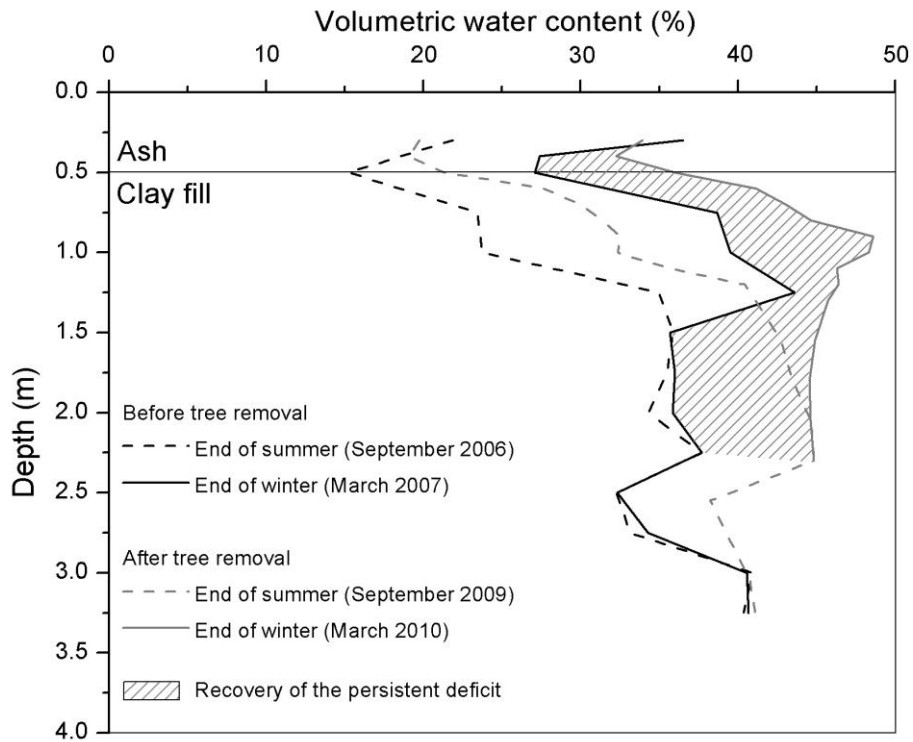
Figure 13: End of winter (March) and end of summer (September) volumetric water content before and after tree removal, at the midslope of the: (a) south slope; (b) north slope.

Biddle (1983, 1998) showed that, for some tree species, a zone of persistently dry soil (i.e., a persistent soil moisture deficit) can develop below the depth that is seasonally affected. End of winter (March) and end of summer (September) volumetric water content profiles before and after tree removal are compared in Fig. 13. The volumetric water content varied seasonally up to a depth of between 1.5 m and 2.25 m when trees were present on the upper part of the embankment, but remained persistently dry at greater depths.

Comparison of the end of winter soil profiles before and after tree removal shows that the volumetric water content within the persistently dry zone increased towards saturation following tree removal (Fig. 13). Seasonal volumetric water content variations then occurred, closer to soil saturation, to a depth of between 2 m and 2.5 m. It is easier for plants to extract water closer to the saturation point, when water is present in larger pores in the fabric of the fill material. As the soil dries, plants would need to generate substantial suctions to remove water from intact peds (lumps) of clay (Smethurst *et al*, 2012). This is shown in the profiles of pore water pressure before and after tree removal (Fig. 14). When trees were present on the embankment slopes pore water pressures varied seasonally between 0 - 20 kPa at the end of winter and -80 kPa at the end of summer. At the end of the summer of 2009, 18 months after tree removal, pore water pressures had increased to around 0 kPa and large soil suctions were not generated by the seasonal change in water content.

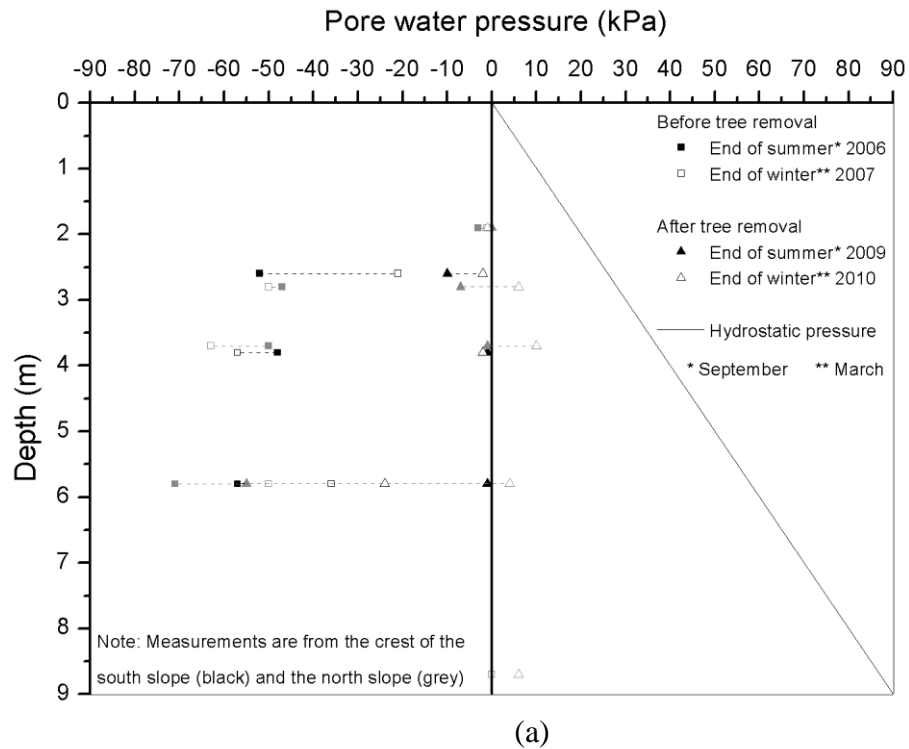
Figure 14: End of winter (March) and end of summer (September) pore water pressures before and after tree removal: (a) crest of both north and south slopes; (b) midslope of both north and south slopes.

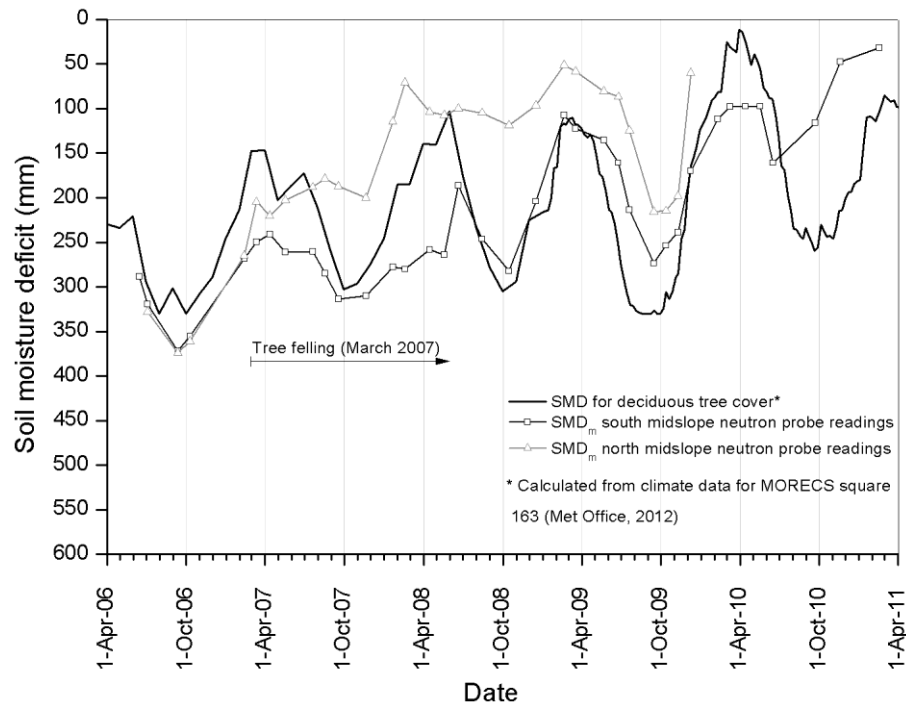
Figure 15: Comparison of soil moisture deficit ( $SMD_m$ ) measured at the embankment midslope with the MORECS SMD calculated from climate data (Met Office, 2012). The calculated  $SMD_m$  for the north midslope stops in December 2009 as the neutron probe access tube was bent by ground movements and could no longer be read to the full depth.

Fig. 14 compares  $SMD_m$  with the MORECS SMD, calculated by the Meteorological Office (2012) for deciduous tree cover in Southend (MORECS square 163). The MORECS (Meteorological Office Rainfall and Evaporation Calculation System) SMD indicates the cumulative balance of soil wetting and drying due to rainfall and evapotranspiration, and is calculated from daily weather data published for 40 km  $\times$  40 km squares covering the UK (Hough *et al.*, 1997). Both the measured ( $SMD_m$ ) and the MORECS soil moisture deficits indicate soil wetting during the winter months (decreasing SMD) and drying during the summer months (increasing SMD).  $SMD_m$  following tree removal on the south midslope varied from slightly drier to slightly wetter than the MORECS SMD, as the persistent SMD created by the trees was gradually lost. However, the south midslope continued to be influenced by trees remaining at the toe of the slope, as shown by the seasonal  $SMD_m$  variation.
